## Why Indeed Did the WTC Buildings Collapse?

By Steven E. Jones

Department of Physics and Astronomy

Brigham Young University

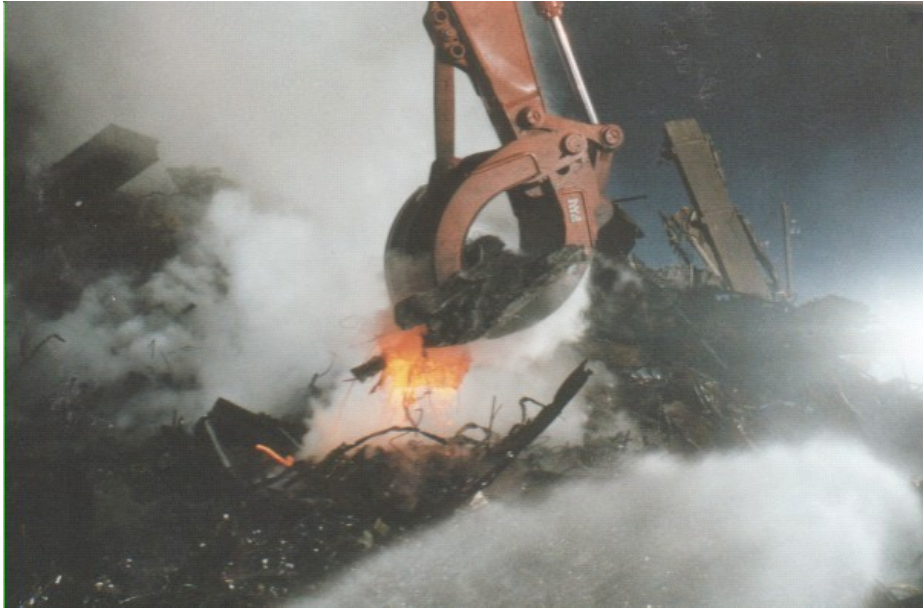
photograph below by Frank Silecchia shows a chunk of the hot metal being removed from the North

Tower rubble on September 27, 2001. Notice the color of the lower portion of the extracted metal -- this tells us much about the temperature of the metal and provides important clues regarding its composition, as we shall see.

Even without a direct elemental analysis, we can rule out some metals based on available data. The photograph in the introduction shows a chunk of hot metal being extracted at ground zero. The hottest portion of the chunk is the lower portion, which was deepest down in the slag, and the metal is seen to be yellow-hot, certainly above cherry-red hot. The following table (see <http://www.processassociates.com/process/heat/metcolor.htm> ) provides data regarding the melting temperatures of lead, aluminum, structural steel and iron, along with approximate metal temperatures by color. Note that the approximate temperature of a hot metal is given by its color, quite independent of the composition of the metal. (A notable exception is aluminum, which due to low emissivity and high reflectivity appears silvery-gray in daylight conditions, at all temperatures whether in solid or liquid forms. Aluminum does incandesce like other metals, but faintly, so that in broad daylight conditions in air, it appears silvery-gray according to experiments done at BYU. [Jones, 2006])

We see from the photograph above that solid metal from the WTC rubble existed at salmon-to-yellow-hot temperature (approx. 1550 - 1900 °F, 845 - 1040 °C.) The temperature is well above the melting temperatures of lead, zinc and aluminum, and these metals can evidently be ruled out since they would be runny liquids at much lower (cherry-red or below) temperatures. However, the observed hot specimen could be structural steel (from the building) or iron (from a thermite reaction) or a combination of the two. Additional photographs of the hot metal could provide further information and advance the research.

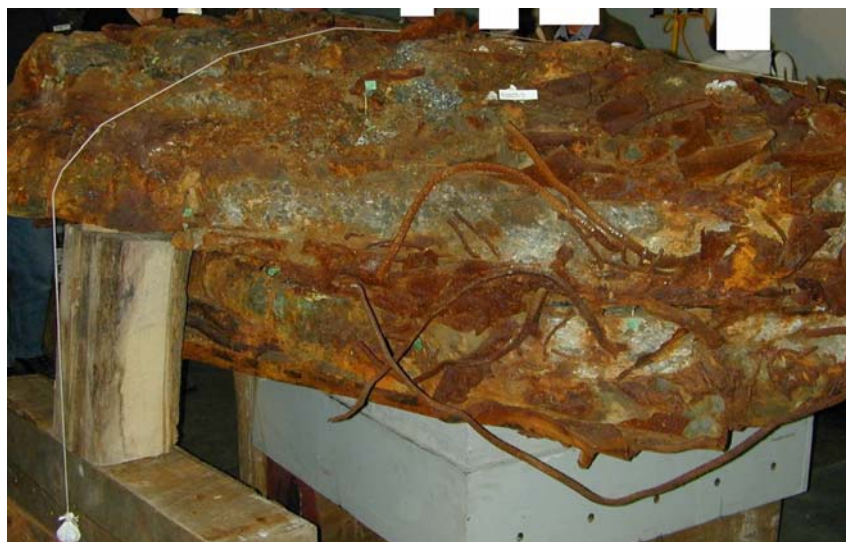
The following photograph has become available, evidently showing the now-solidified metal with entrained material, stored (as of November 2005) in a warehouse in New York:

The abundance of iron (as opposed to aluminum) in this material is indicated by the reddish rust observed. When a sample is obtained, a range of characterization techniques will quickly give us information we seek. X-ray energy dispersive spectrometry (XEDS) will yield the elemental composition, and electron energy-loss spectroscopy will tell us the elements found in very small amounts that were undetectable with XEDS. Electron-backscattered diffraction in the scanning electron microscope will give us phase information; the formation of certain precipitates can tell us a minimum temperature the melt must have reached. We will endeavor to obtain and publish these data, whatever they reveal.

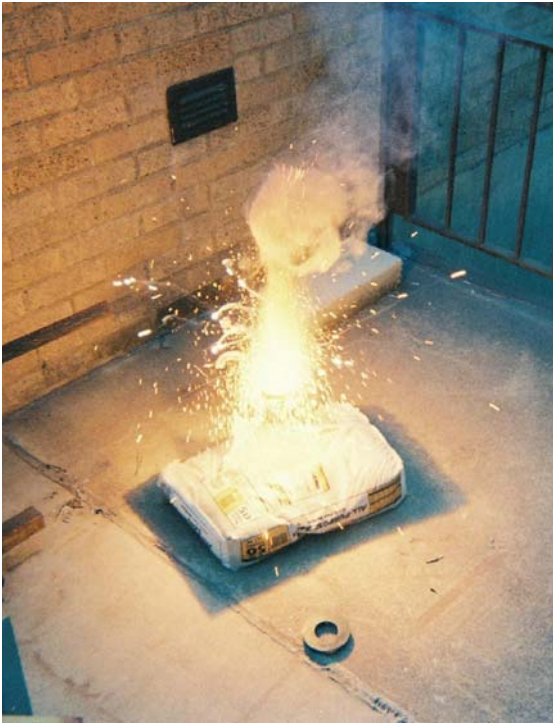
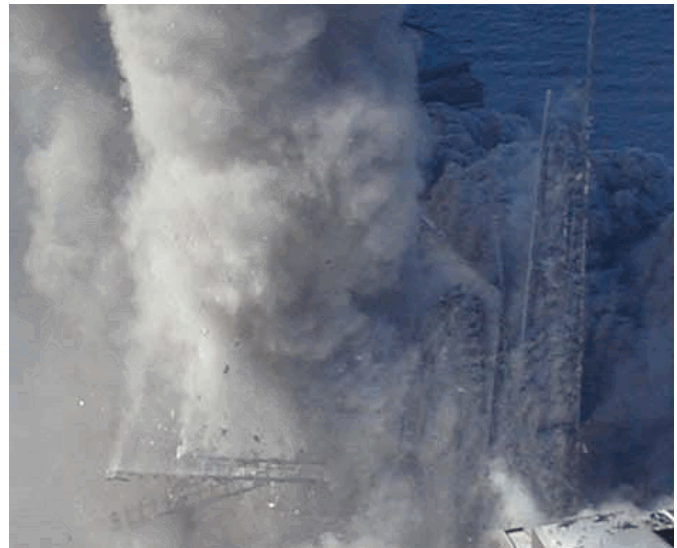
An intriguing photograph (below right) taken by Rob Miller, photojournalist with the New York Post, provides additional photographic evidence (Swanson, 2003) for the use of thermite or a sulfur-containing derivative such as thermate. We see debris and dust as WTC 1 collapses, with WTC 7 seen in the foreground, across the street from WTC 1. The next photograph (left), for comparison, the thermite reaction with a grayish-white aluminum-oxide dust plume extending from white-hot molten iron "blob" from the reaction. (Experiment at BYU by the author in which thermite-plus-sulfur cut through a steel cup in a fraction of a second).

Mr. Miller captured two ladder-like structures in his photograph (lower left of the right-most photograph above; a cleaner photo is being sought), consistent with steel structures observed in the core of WTC 1. Observe the grayish-white plumes trailing upward from white "blobs" at the left-most extremities of the upper structure. (The lower structure is mostly obscured by dust.) It is possible that thermite cut through structural steel and that what we now observe is white-hot iron from the reaction adhering to the severed ends of the steel, with grayish-white aluminum oxide still streaming away from the reaction sites. The observations are *consistent with the use of thermite or one of its variants*. However, further analysis of this and additional photographs from the series is necessary before any firm conclusions can be drawn about this line of evidence.

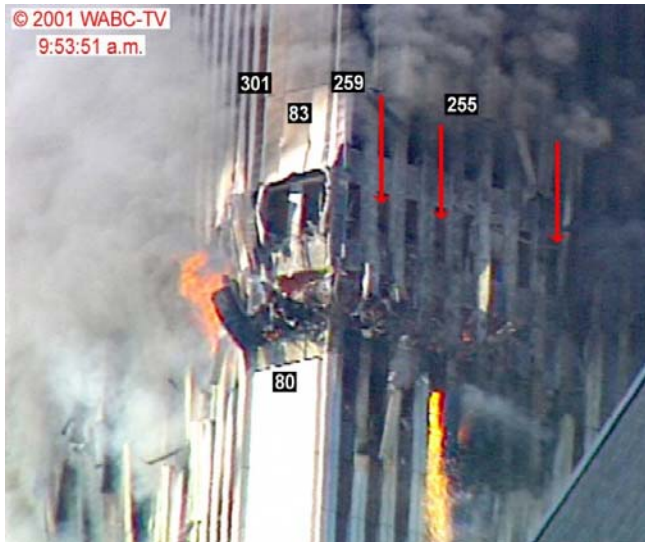
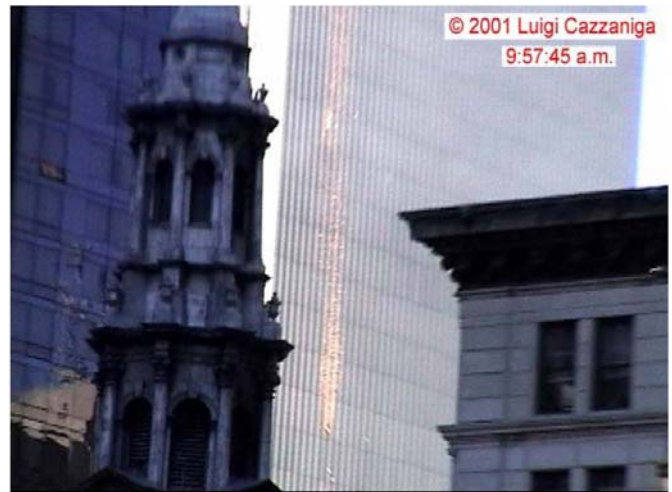
Dramatic footage reveals yellow-to-white hot molten metal dripping from the South WTC Tower just minutes before its collapse: <http://video.google.com/videoplay?docid=-2991254740145858863&q=cameraplanet+9%2F11>. Photographs capture the same significant event, clearly showing liquid metal dripping from the South Tower, still hot as it nears the ground below:

Who can deny that liquid, molten metal existed at the WTC disaster? The yellow color implies a molten-metal temperature of approximately 1000 °C, evidently above that which the dark-smoke hydrocarbon fires in the Towers could produce. If aluminum (e.g., from the plane) had melted, it would melt and flow away from the heat source at its melting point of about 650 °C and thus would not reach the yellow color observed for this molten metal. Thus, molten aluminum is already ruled out with high probability. But molten iron with the characteristics seen in this video is in fact consistent with a thermite-reaction attacking the steel columns in the Tower, thus weakening the building just prior to its collapse, since thermite produces molten iron at yellow-to-white hot temperatures. (As some of the molten metal hits the side of the building in the video clip above, the white-hot interior is evidently exposed as the metal "splashes".) Also, the fact that the liquid metal retains an orange hue as it nears the ground (right photograph) further rules out aluminum, and suggests a mid-flight thermite reaction (typical of thermite). The reader may wish to compare the dripping molten metal observed on the corner of the South Tower just before its collapse with the dripping molten metal from known thermite reactions: <http://www.checktheevidence.com/911/Thermite2.htm> .

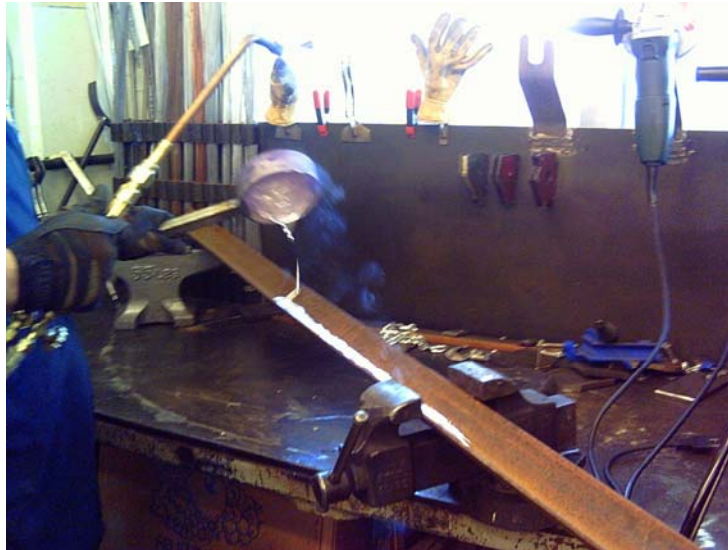
We also noted that while a steel pan holding the aluminum glowed red and then yellow hot, the molten aluminum inside retained its silvery-gray color, adding significantly to the evidence that the yellow-white molten metal dripping from the South Tower shortly before its collapse was NOT molten aluminum. (Recall also that the yellow color of the molten metal (video clip above) implies a temperature of approximately 1100 °C -- too high for the dark-smoke hydrocarbon fires burning in the building.) This is point worth emphasizing: aluminum has low emissivity and high reflectivity, so that in daylight conditions molten aluminum will appear silvery-gray, while molten iron (with its characteristic high emissivity) will appear yellow-white (at ~1100 °C) as observed in the molten metal

Molten aluminum poured onto rusted steel: no violent reactions observed at all.

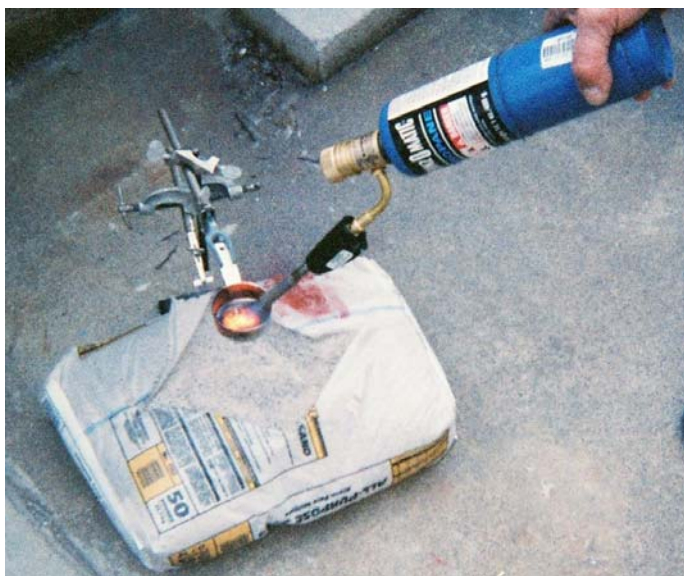
It is important to note that initiating the thermite reaction requires temperatures well above those achieved by burning jet fuel or office materials -- which is an advantage of using thermite charges over conventional monomolecular explosives such as TNT, RDX and PETN. Below is a photograph of an experiment performed by the author and colleagues at BYU in which a sample of thermite was heated to orange-hot temperature (about 1700 °F). We demonstrated that the thermite reaction would not ignite at this high temperature. Later, the thermite reaction was triggered by burning a magnesium strip in contact with the thermite. An electrical superthermite "match" could have been used and remotely triggered via radio signal.

Thermite did not ignite when heated with a propane torch.

DRAFT 6.2 (New photo of thermite heated by propane torch and NOT igniting; from experiments done by author and colleagues at BYU.)

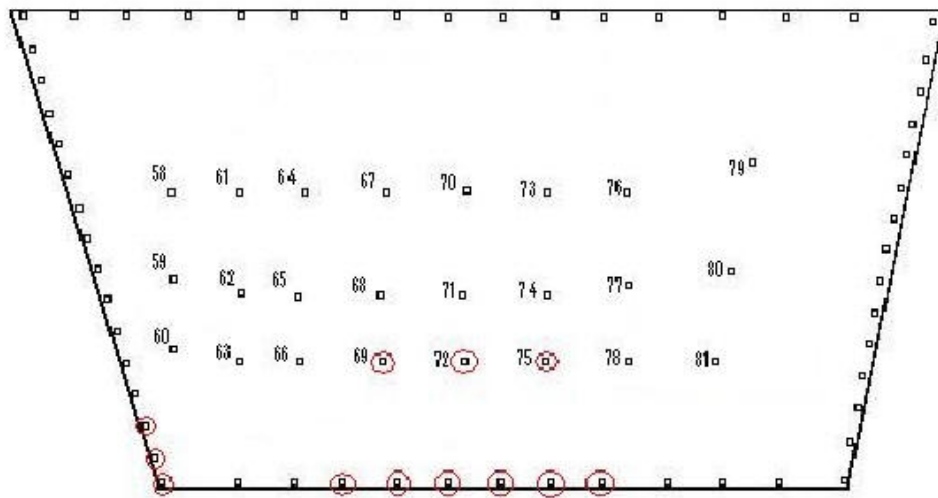
As you observed (link above), WTC 7 collapsed rapidly and nearly-straight-down symmetrically -- even though fires were randomly scattered in the building. WTC 7 fell about seven hours after the Towers collapsed, even though no major persistent fires were visible (considerable dark smoke was seen). There were twenty-four huge steel support columns inside WTC 7 as well as huge trusses, arranged non-symmetrically, along with some fifty-seven perimeter columns, as indicated in the diagram below (FEMA, 2002, chapter 5; NIST, 2005).

Diagram showing steel-column arrangement in WTC 7, view looking down on the roof. Circled columns were possibly damaged due to debris from WTC 1 collapse, some 350 feet away (NIST, 2005) so the damage was clearly non-symmetrical, and evidently, none of the core columns was severed by falling debris. WTC 7 was never hit by a plane.

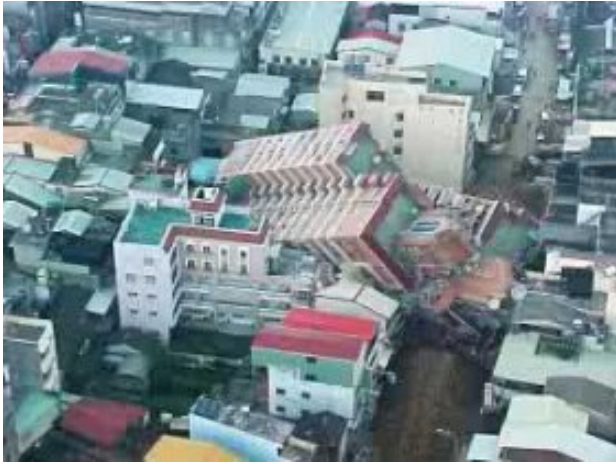
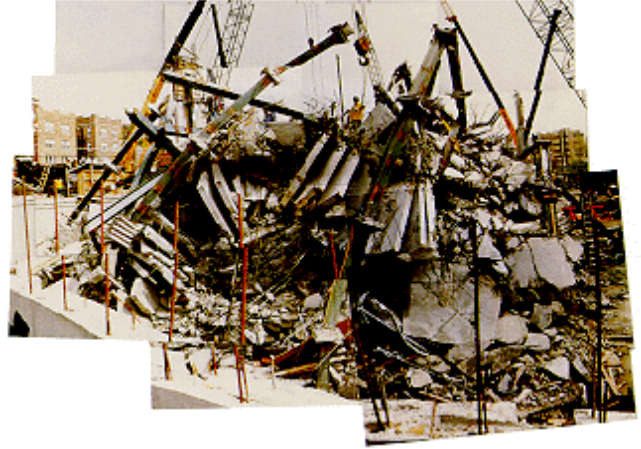
Non-symmetrical collapse of tall buildings when due to random causes. L'Ambiance Plaza collapse (right) shows how pancaked concrete floor slabs are largely intact and clearly reveal stacking effects with minimal fine dust, as expected from random progressive collapse. By contrast, concrete floors in the Twin Towers and WTC 7 were pulverized to dust -- as is common in controlled demolitions using explosives.

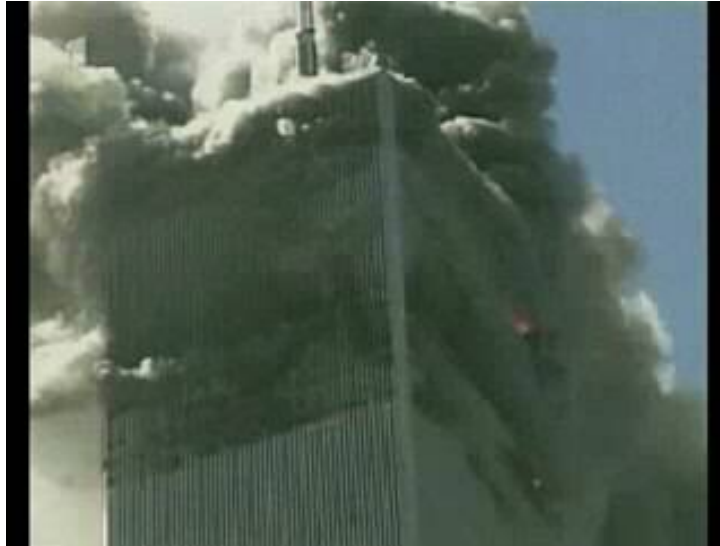
Review of videotape recordings of the collapse taken from various angles indicates that the transmission tower on top of the structure began to move downward and laterally slightly before movement was evident at the exterior wall. This suggests that **collapse began with one or more failures in the central core area of the building.** (FEMA, 2002, chapter 2; emphasis added.)

North Tower showing antenna (top) at beginning of collapse.

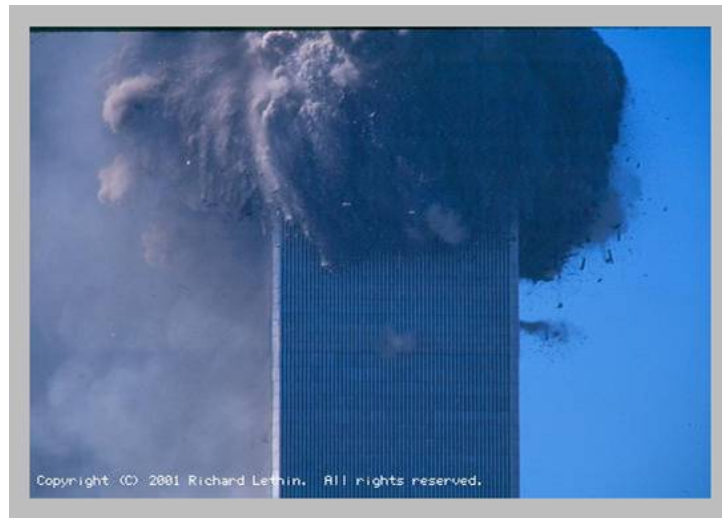
North Tower during top-down collapse.

Notice mysterious horizontal plumes far below pulverization region.

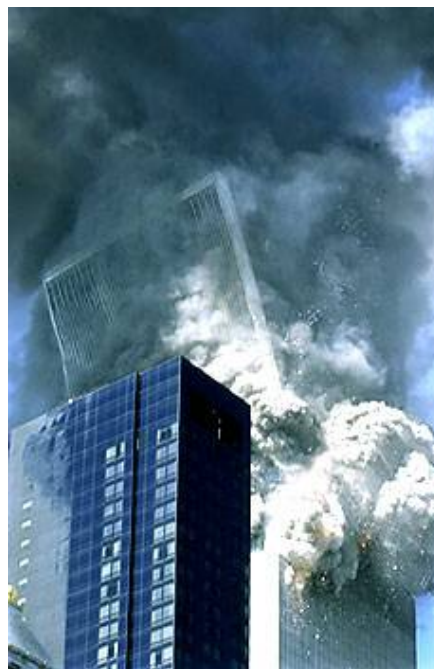
Top ~ 30 floors of South Tower topple over.  
What happens to the block and its angular momentum?

We observe that approximately 30 upper floors begin to rotate as a block, to the south and east. They begin to topple over, not fall straight down. The torque due to gravity on this block is enormous, as is its angular momentum. But then – and this I’m still puzzling over – this block turned mostly to powder *in mid-air*! How can we understand this strange behavior, without explosives? Remarkable, amazing – and demanding scrutiny since the US government-funded reports failed to analyze this phenomenon. But, of course, the Final NIST 9-11 report “**does not actually include the structural behavior of the tower after the conditions for collapse initiation were reached.**” (NIST, 2005, p. 80, fn. 1; emphasis added.)

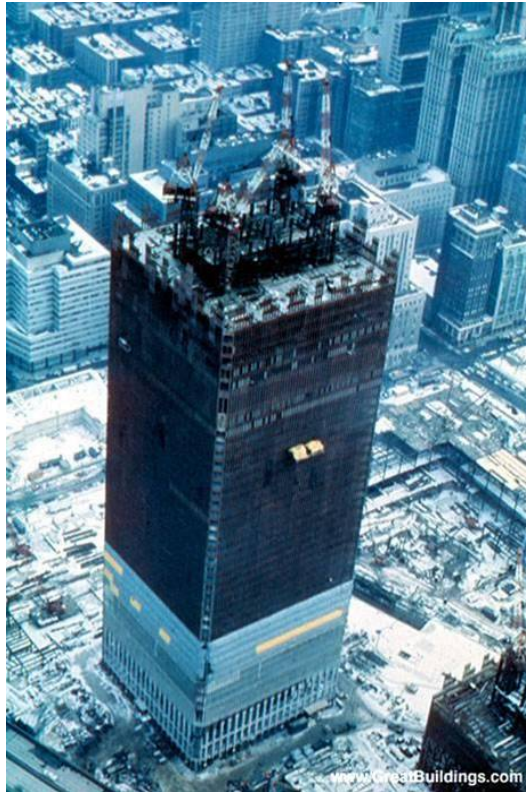
The WTC towers were solidly constructed with 47 steel core columns and 240 perimeter steel columns. 287 steel-columns total.

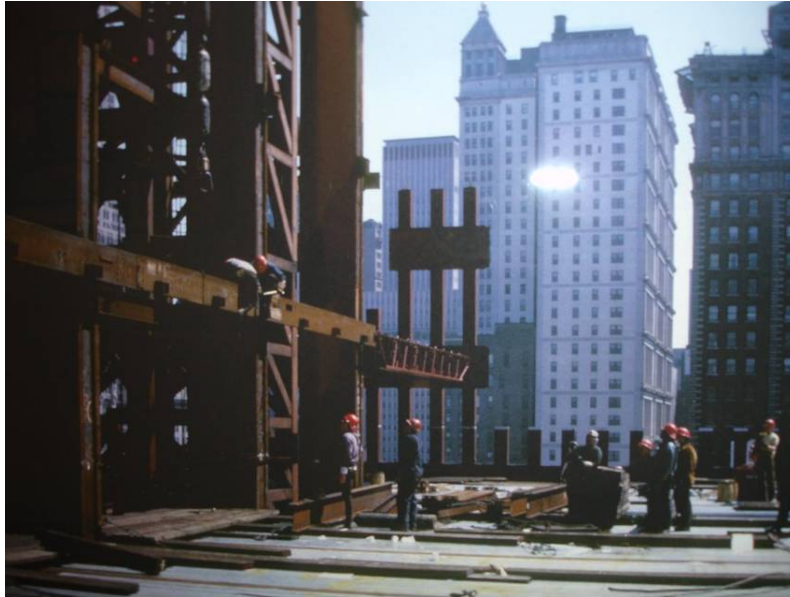
Steel-frame: Huge core (left) is an enormous heat sink. Notice workers standing on floor pan which is firmly attached to the interconnected core columns.
